Date: January 29, 2025

From: Stuart Finney, PE, SE – KPFF
Lee Glassford, PE, SE – KPFF
Seth Thomas, PE, SE – KPFF

Re: Gearhart Public Safety Building – Seismic/Tsunami Assessment

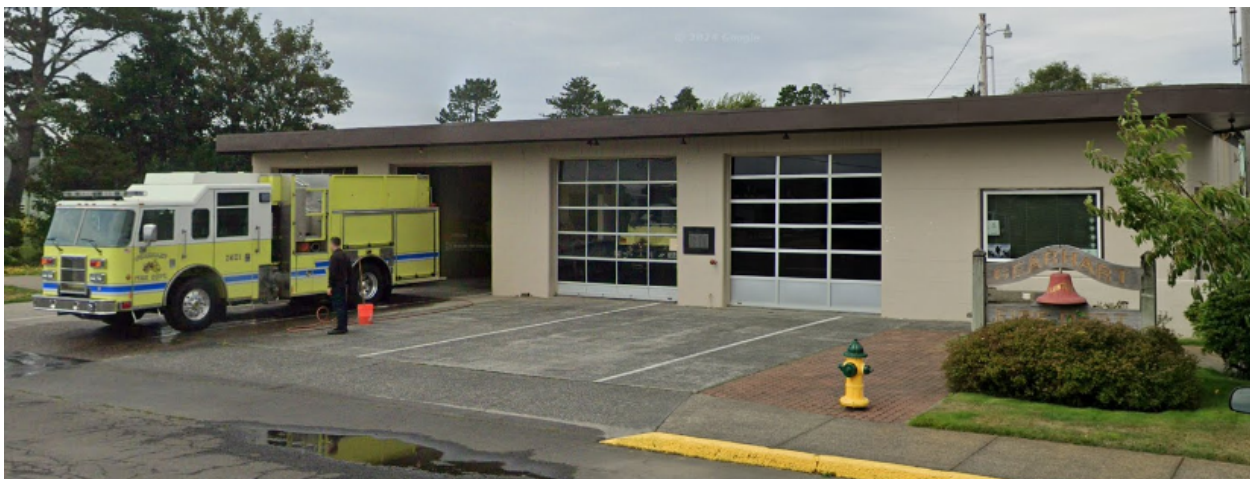
Figure 1: Overall Exterior

Overall, the building appears to be nearing the end of its expected service life. There are localized areas of structural deterioration observed in the exterior wall and roof framing. Erosion is evident on numerous exterior CMU blocks – as shown in Figure 2 below. A crack is present on the northwest corner of the building, extending approximately half the height of the wall. At this location, in some sections of the crack, the joint mortar appears to have eroded – as shown in Figure 3 below.

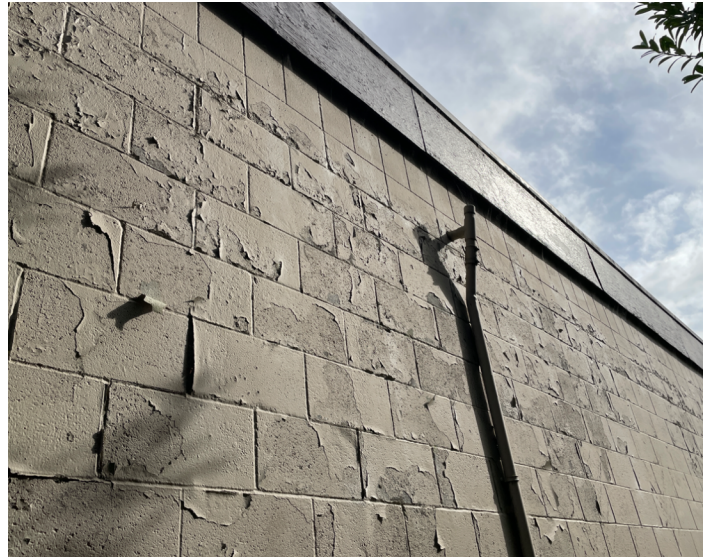
Figure 4: West Wall Peeling Paint

Extensive paint peeling is visible around the building's perimeter, though it does not appear to have significantly impacted the condition of the CMU blocks. The fascia board shows significant weathering in several areas and appears to be nearing the end of its service life.

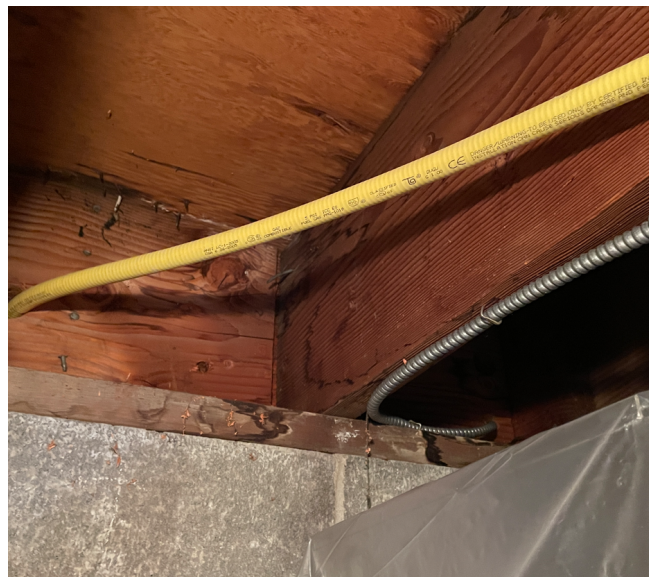
Figure 5: Roof Framing Sill Plate

The existing wood roof framing is visible in limited locations inside the building and appears to be in generally good condition, with some evidence of past water intrusion in isolated areas. However, the intrusion does not appear to be extensive, and the wood appears to be structurally sound. The sill plates atop the CMU walls, while not pressure-treated, also show signs of past water exposure but do not appear to be structurally compromised when observed from the interior.

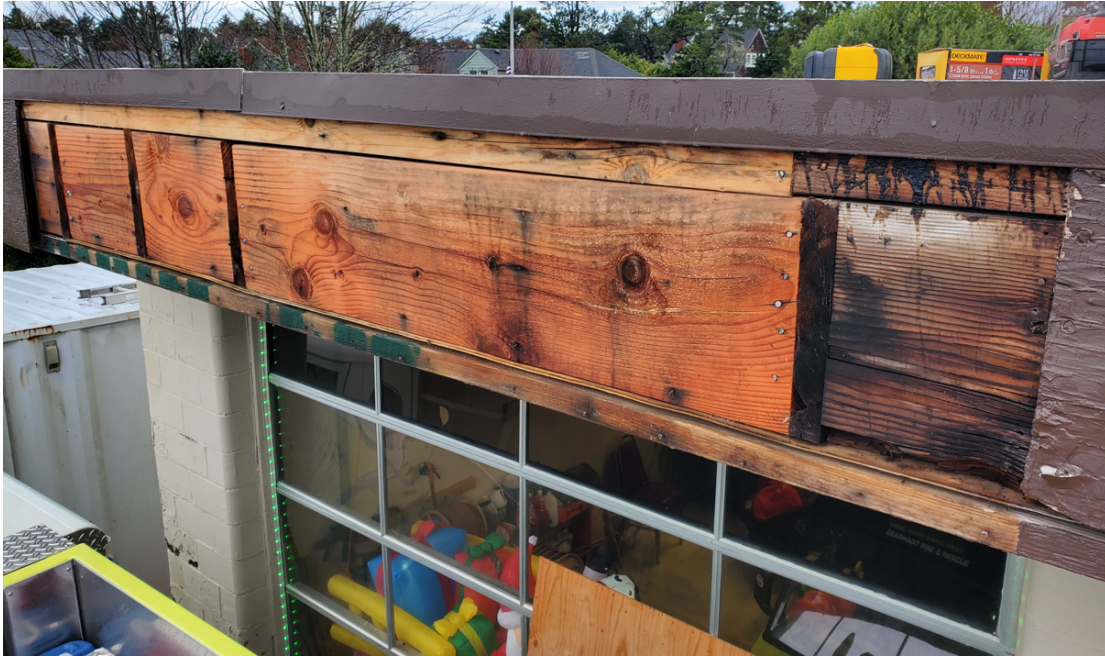
Figure 6: Exterior view of Framing

A recent windstorm removed a section of fascia board at the southwest corner of the building, exposing the rafter ends and rim board as shown in Figure 6. The exposed rafter ends were observed to be decayed and have significant deterioration, and there appears to be decay in the original rim board. Since the roof flashing detail is likely the same around the entire perimeter of the building, we would expect a large portion of the rafter ends to have at least some decay.

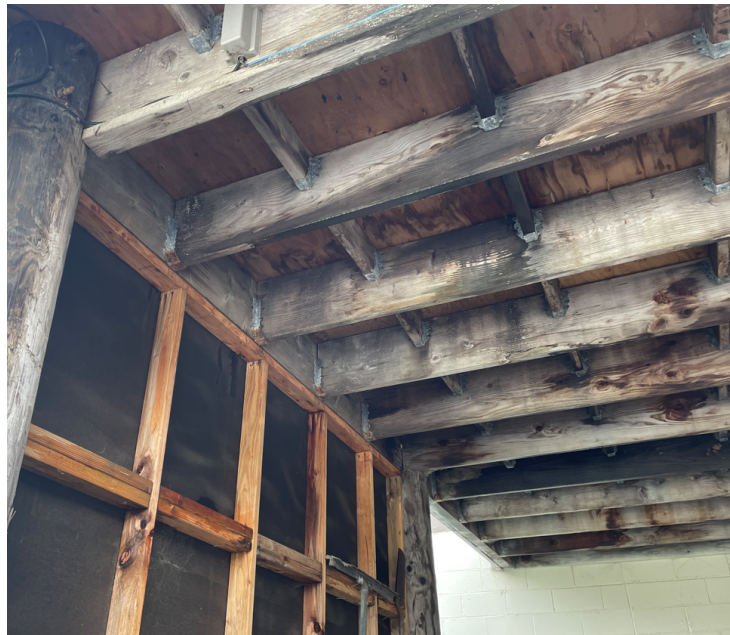
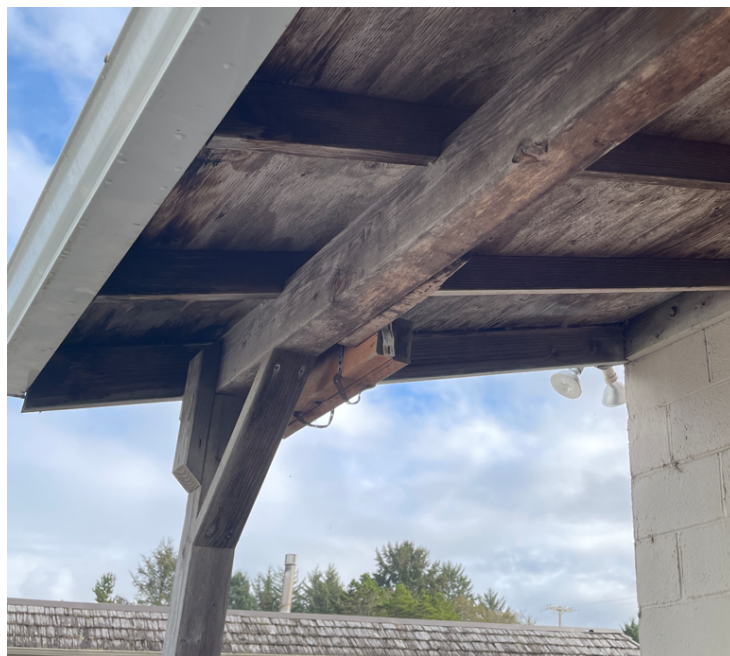
In the building's reentrant corner on the northeast, two small wood-framed canopies are attached to the exterior CMU walls. These canopies are bolted to the wall faces using ledger boards and are supported by posts on the side opposite the walls. Based on their construction details, these canopies are unlikely to have been designed for seismic loads. The canopies do not appear to have been constructed with pressure-treated wood and exhibit extensive water damage. Based on their age and exposure, some decay and loss of wood density is expected. Additionally, many metal connectors on the canopies show significant corrosion.

Figure 7: Exterior Canopy Framing

Figure 8: Exterior Canopy Framing

The exterior wood-framed canopies lack an adequate lateral system in both directions. For lateral loads perpendicular to the CMU walls, there are no lateral ties connecting to the main wood roof diaphragm, and lateral forces would be resisted through cross-grain bending of the wood ledger. For lateral forces parallel to the CMU walls, wood-framed knee braces are used; however, there do not appear to be sufficient fasteners to effectively transfer lateral forces through these braces. These canopies would likely collapse during the design earthquake and could block exit paths out of the building. Additionally, the canopy ledgers are below the main roof elevation and will impart additional out of plane loading on the CMU walls. The CMU walls are likely not adequate to resist additional out of plane seismic loading from the canopies. This could lead to an out-of-plane wall failure and loss of gravity support for the interior roof framing and canopy framing.

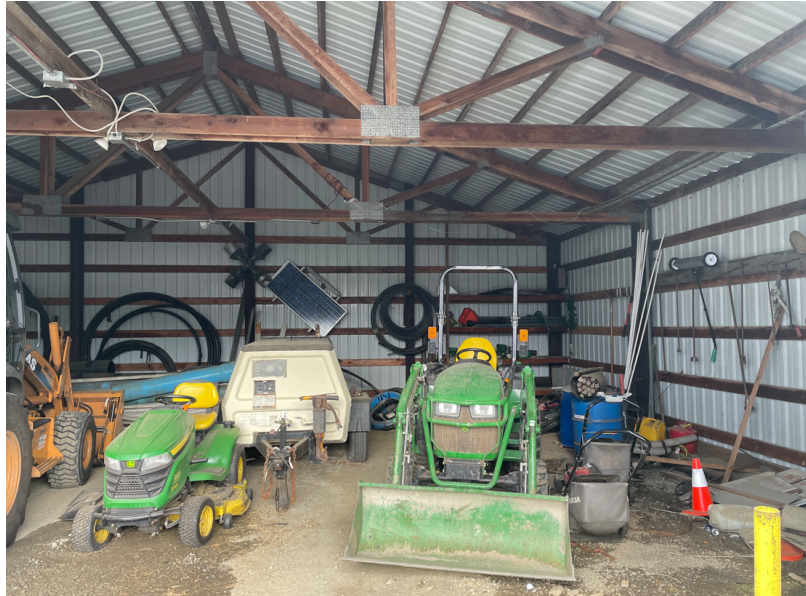
Figure 9: Storage Building Framing

At the Northeast corner of the site there is a small wood framed storage building. The building is approximately 35'x 40', one story, and has a gabled roof. The building is framed with three bays of wood trusses supported on wood posts. Spanning between the roof trusses are 2x purlins supporting metal roof panels. The walls consist of metal roof panels spanning vertically, and are braced by flatwise wind girts. There is no slab on grade in the building, and no foundations are visible.

The storage building lacks a well-defined seismic lateral force resisting system. Any resistance to lateral shear forces relies primarily on the metal roof panels, which serve as both siding and roofing. However, the building's south side features a large sliding barn door that effectively reduces the available shear-resisting length by approximately 50%.

Overall, the storage building exhibits minimal lateral shear resistance, and its structural performance during a seismic event is expected to be poor.

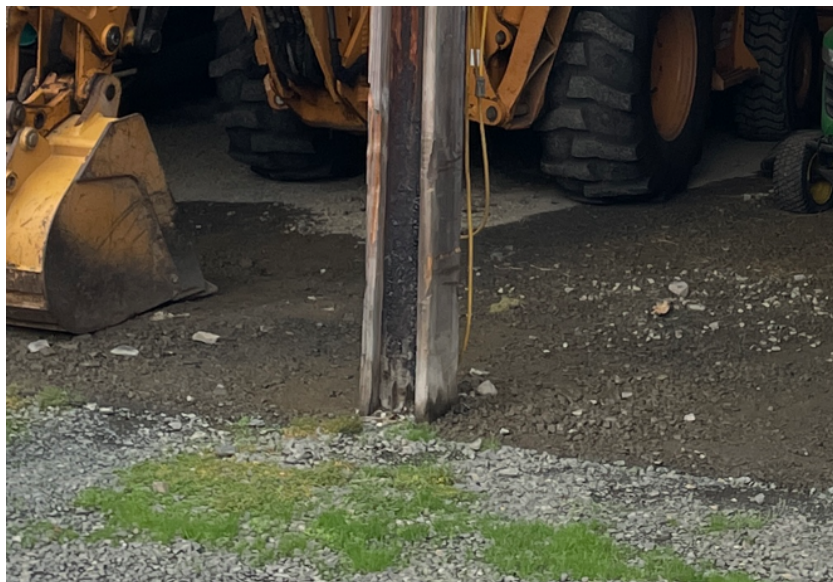
Figure 10: Wood Post in Contact with Grade

The roof framing does not appear to be framed with pressure treated wood and there appears to be some water damage in some of the roof framing purlins and trusses. The wood posts do appear to be pressure treated lumber; however, they are in contact with grade and may have some deterioration at the base – as shown in Figure 10.

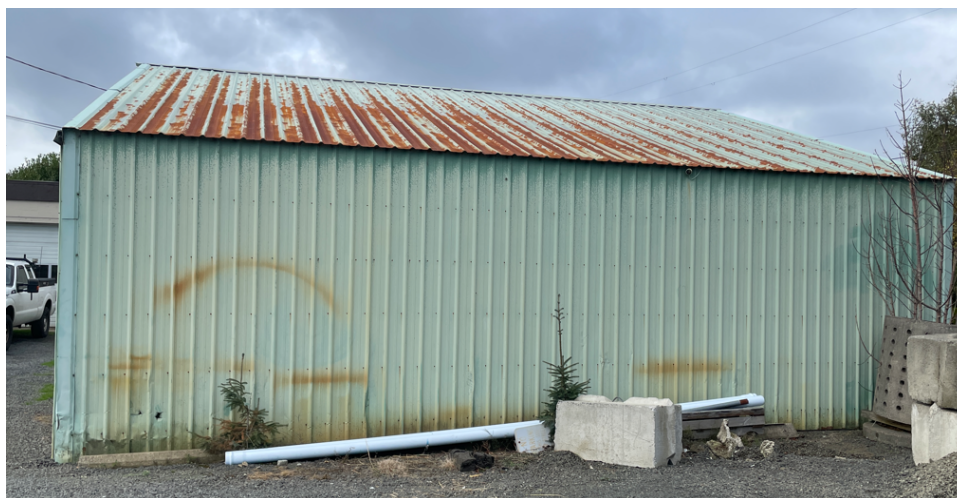
Figure 11: Metal Panel Corrosion

The metal roof panels that make up the roof and exterior walls of the storage building are corroded significantly on the roof, and in many locations on the walls – as shown in Figure 11. Additionally, many of the screws that fasten the metal panels to the wood framing are corroded.

to provide significant shear resistance. Observations also indicate that these fasteners are corroded, which likely further reduces their effectiveness in resisting shear forces.

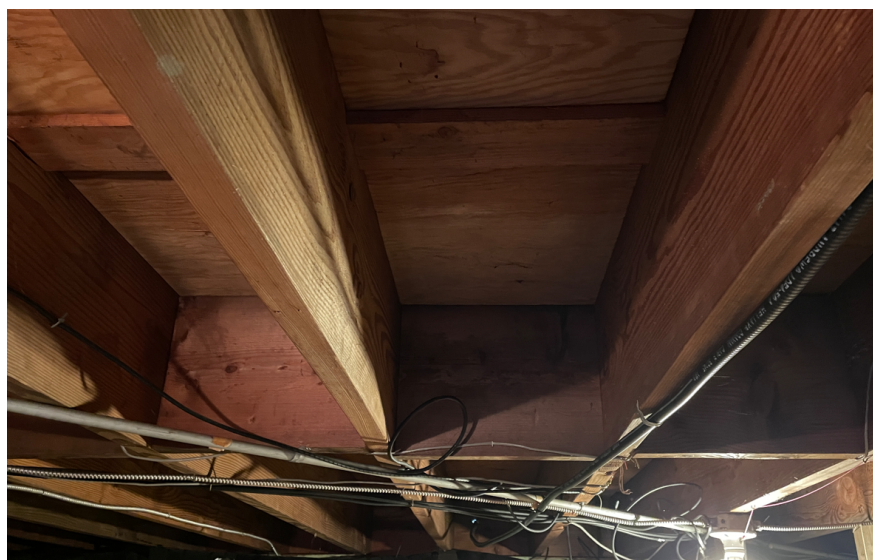
Figure 12: Potential Roof Sheathing Blocking

The diaphragm appears to consist of wood structural panels and blocking over the CMU shear walls. The roof sheathing appears to have blocking at panel edges, as observed in Figure 12, but may not be consistent throughout the building. Transfer of seismic forces to from the diaphragm to the CMU wall appears to be through the blocking and top plate then into the CMU wall using top plate anchor bolts. Nailing of the diaphragm blocking is unknown; however, it was observed onsite that at some locations the nailing missed the blocking, thus is not effective. No anchors from the plate into the wall were observed during our site observation; however, we would assume some anchor bolts to be present based on the era of construction. Regardless, the number of anchor bolts from sill plate into the top of the CMU wall is less than we would expect to be needed to adequately transfer lateral forces. Therefore, we do not believe there is adequate diaphragm capacity to transfer lateral forces into the shear walls.

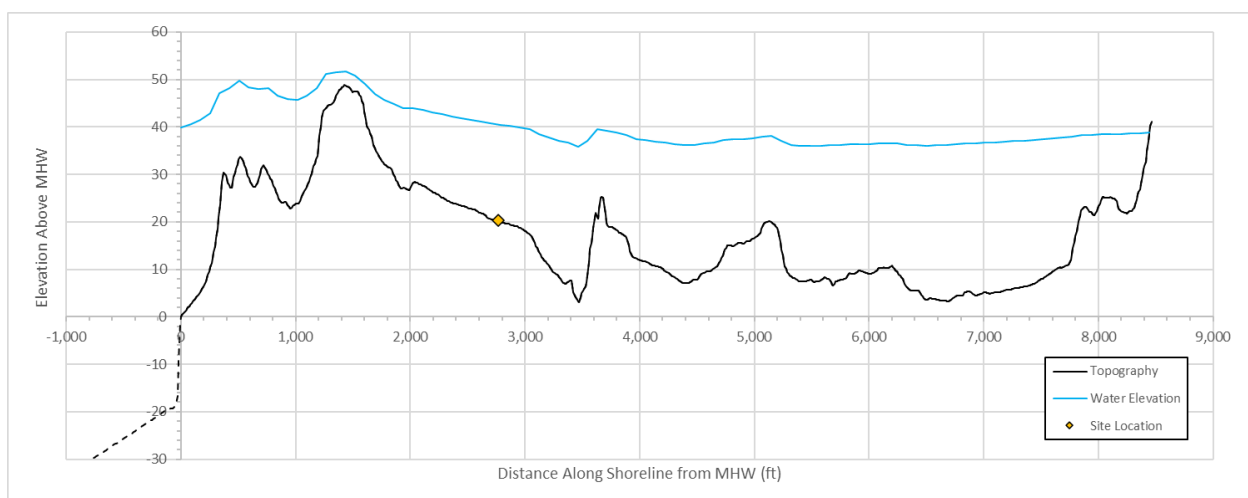
Figure 13: Tsunami Water Level Analysis

Based on the site location, the building is within the tsunami inundation zone as defined by the 2022 OSSC. The building is a Risk Category IV “Essential Facility” structure, so design for tsunami loading is required per the OSSC and IBC. The site is located approximately 2,770 feet inland from the mean high-water line at a post-subsidence elevation of approximately 20ft – as shown in Figure 13. In the event of the design tsunami, the anticipated inundation depth is approximately 21ft feet above the post-subsidence grade, with a flow velocity of approximately 28 feet per second (19 MPH).

These conditions create significant uplift (buoyancy) and lateral loading (hydrodynamic drag) that the building is not capable of resisting in its current condition. The effective design tsunami base shear is approximately 5x the seismic base shear in the east west direction. The lateral force resisting system is not capable of resisting the net lateral load and the CMU walls are inadequate to resist the out of plane loads.
